Product Data

Heat Activated Repair Compound for Application and Repair of Hot Surfaces

Belzona® 1251

HA-Metal

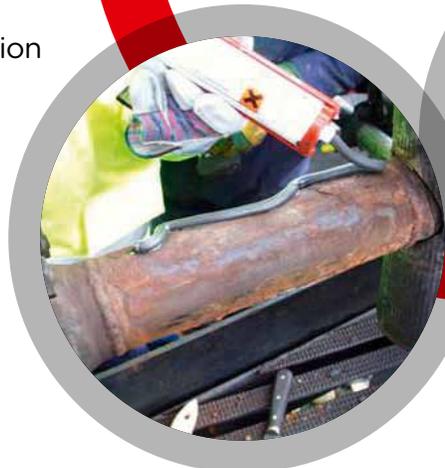
Bonding Doubler Plates

- Filling of corrosion pits
- Repair of thin wall defects
- Bonding of doubler plates
- Local repairs
- Leak sealing of pipework

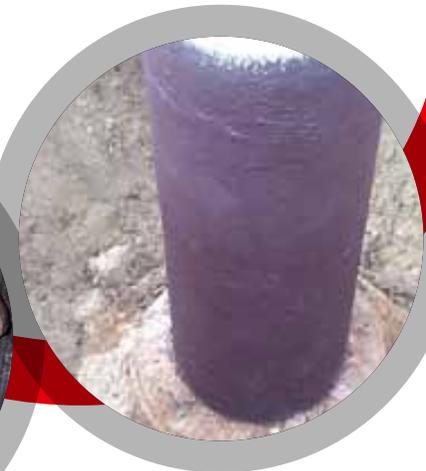
Repair of Thin Wall Defects

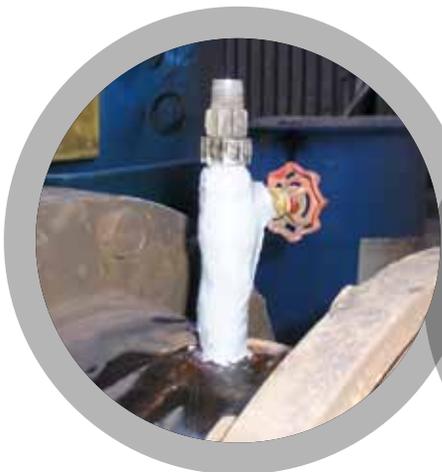
Leak Sealing of Pipework

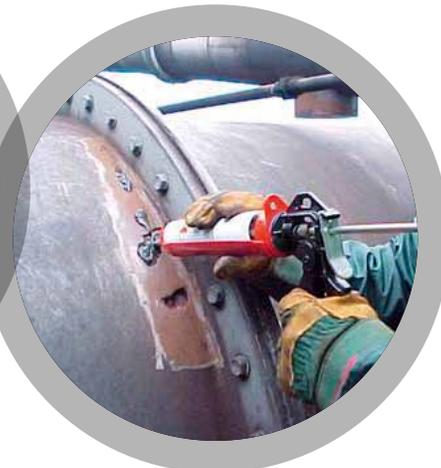
Filling of Corrosion Pits

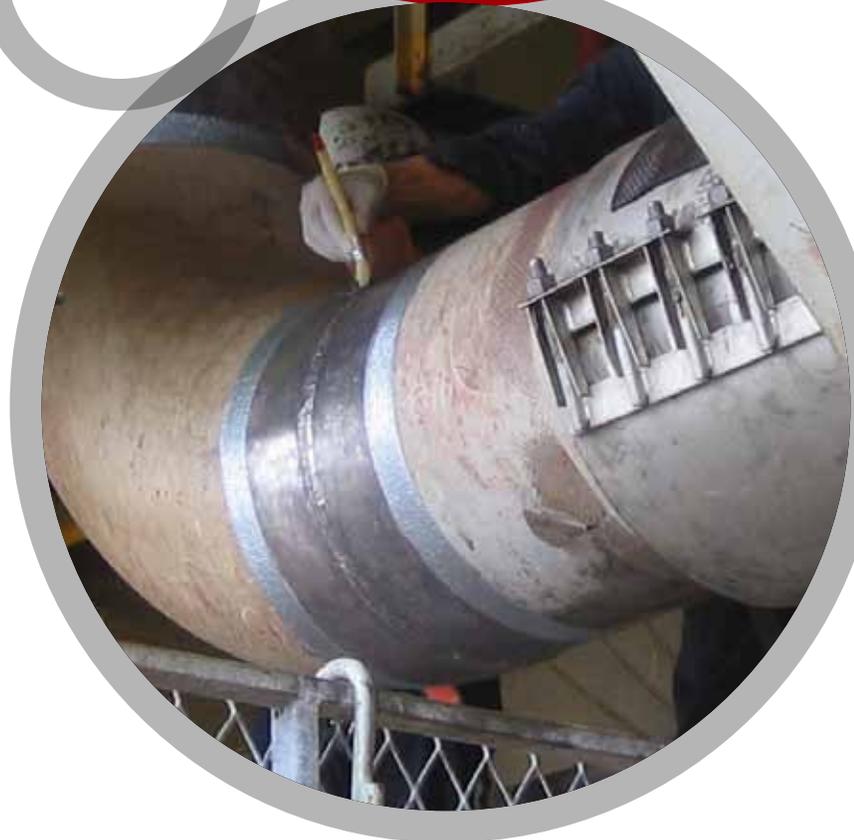
Local Repairs
